Rimkus Consulting Group, Inc.
Eight Greenway Plaza, Suite 500
Houston, TX 77046
(800) 580-3228 Telephone
(713) 623-4357 Facsimile

Re: RCG File No: 11009971
LLV Number: 0209452
VMF Location: 1530 Greensmark Drive in Houston, Texas
Subject: Final Report

Rimkus Consulting Group, Inc. was retained to examine LLV 0209452, VIN 1GBCS10E4M2908832. The fire occurred on June 13, 2016 at around 12:30 P.M. the operator of the vehicle at the time of the fire, was unavailable for interview but reportedly stated the vehicle's engine died while delivering mail on his route and backfired during subsequent attempts to restart it. Soon thereafter, smoke was observed from beneath the hood as well as flames.

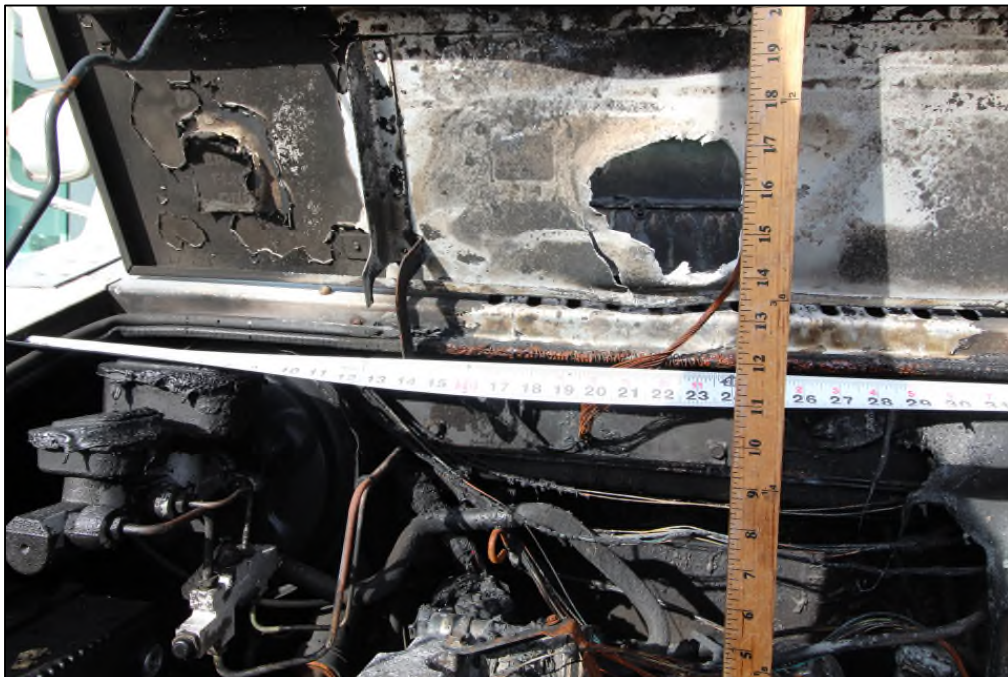
Photograph 4

Additional image of engine damage.

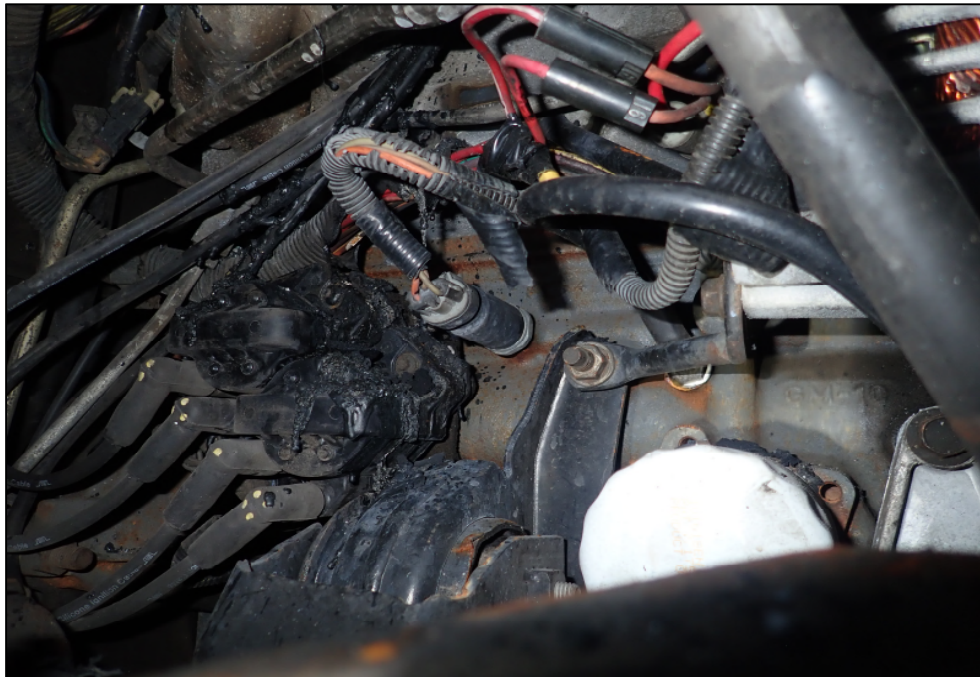
Photograph 7

Coil packs sustaining drop down thermal damage.

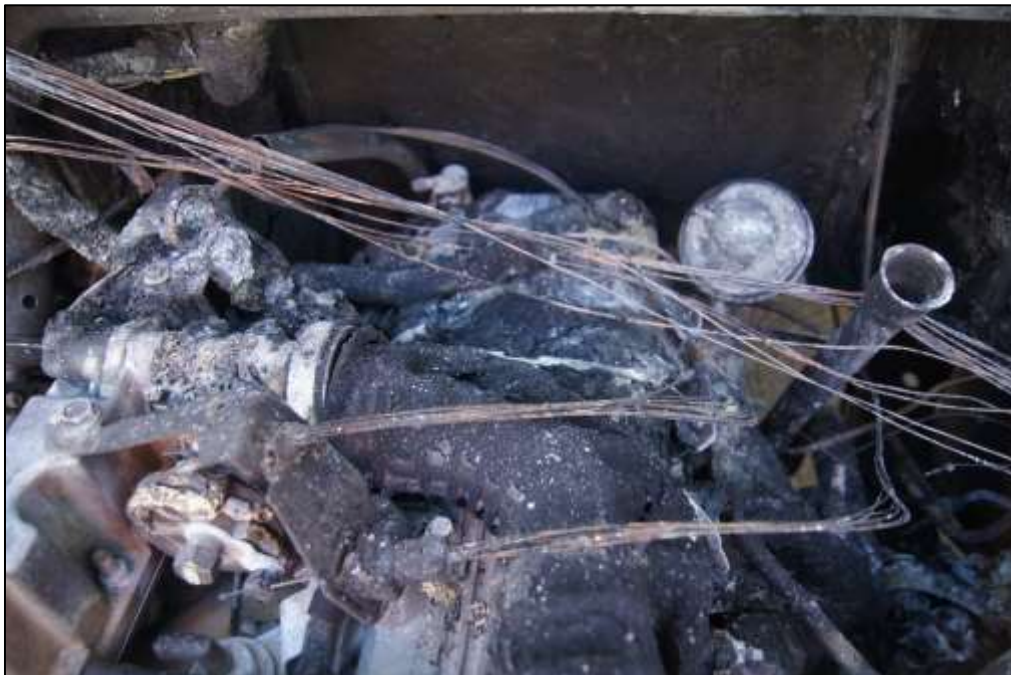
Photograph 6

Origin area.

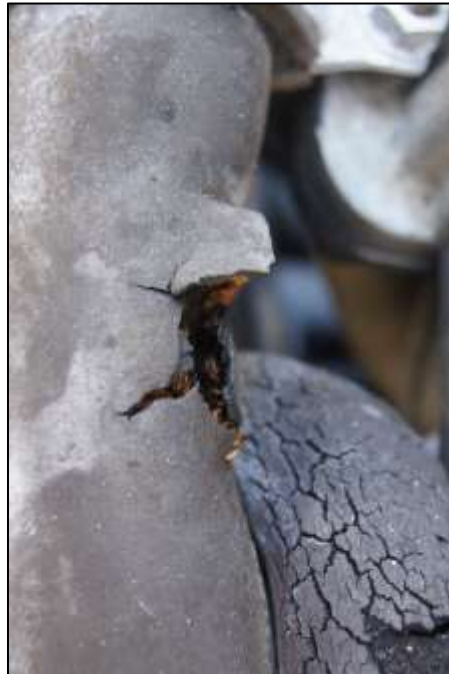
Photograph 8
Damage to upper hose.

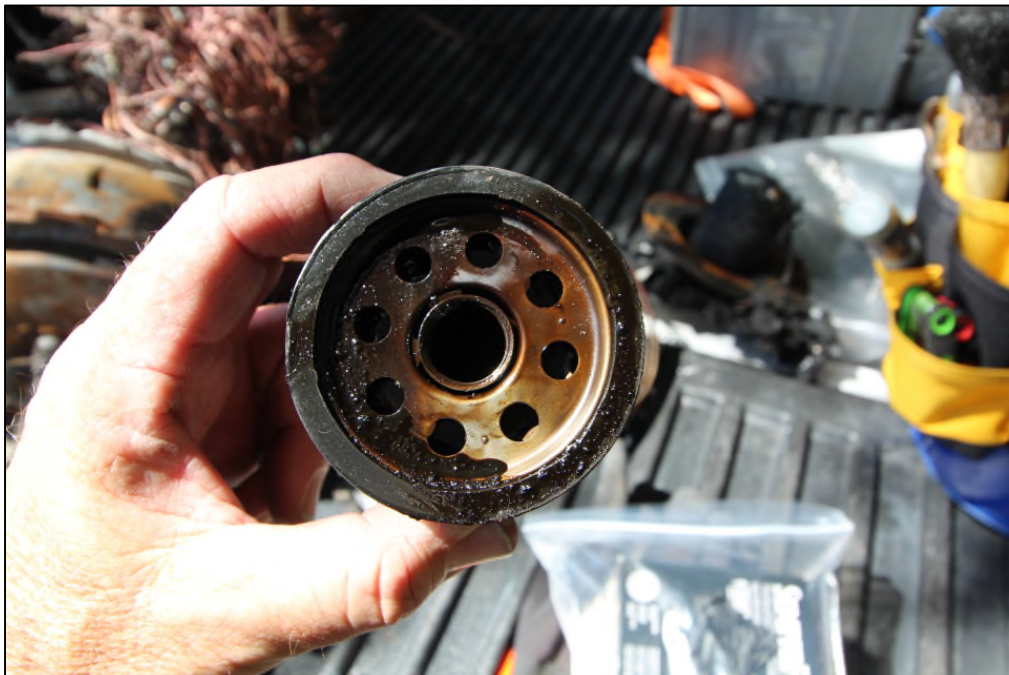
An overall inspection of the engine block was conducted. No abnormal engine block damage was observed. During this inspection both oil sample and oil filter were recovered for analysis. The engine oil sample was contaminated with water due the vehicle being left open to the environment as well as additional water being added during fire extinguishment. The engine oil and oil filter was submitted for additional analysis by FAST laboratory. The results were mild contaminants or wear metals nothing considered abnormal.

Photograph 4
Oil filter retained.

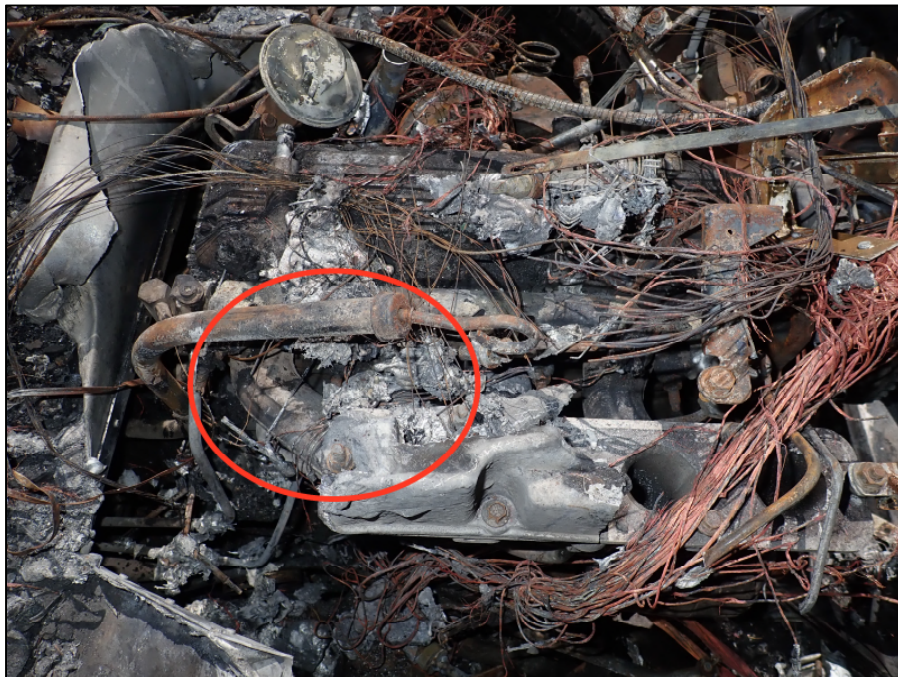
Photograph 8
Concentrated area of fire damage.

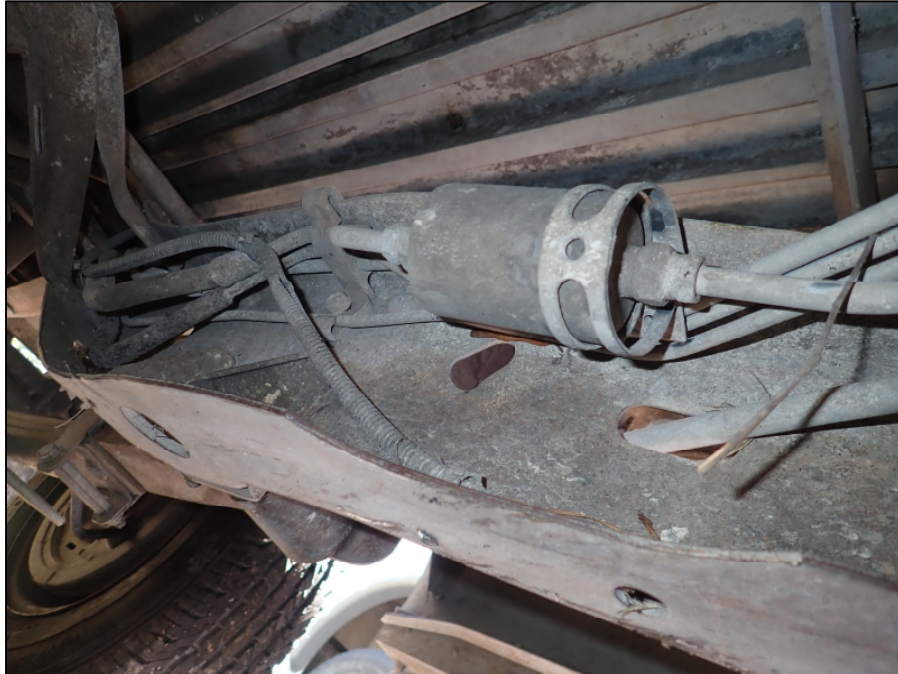
part to complete the casual factors potentials. The fuel system was examined and found to be severely damaged and total material loss to several components. The fuel filter was mounted to the frame rail mid-ship and was in pristine condition. Due to the severe fire damage and materials loss to the fuel system, a failure to the fuel system could not be eliminated.

Photograph 9
Fuel filter.

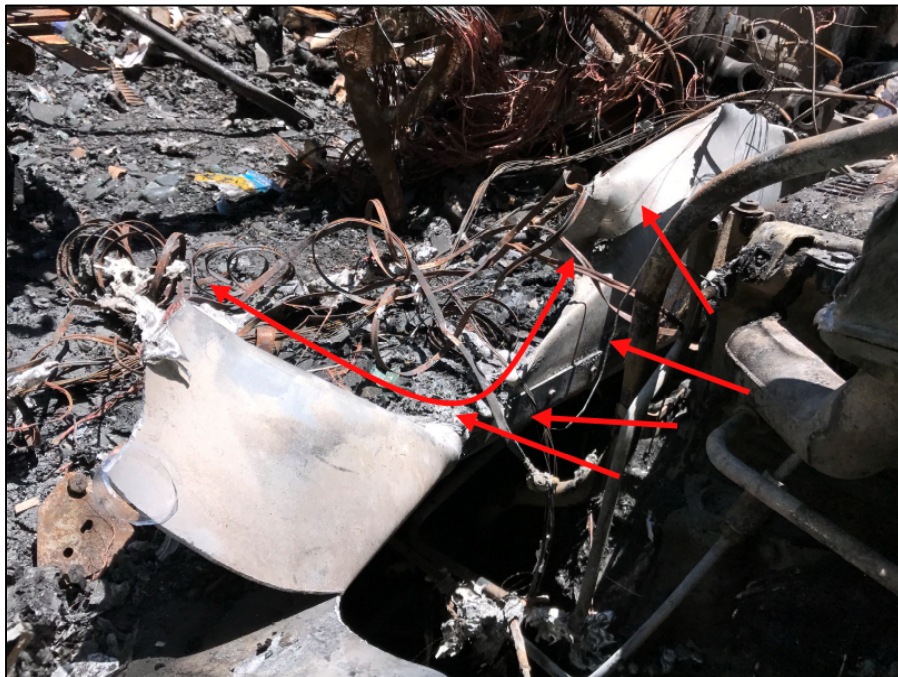
The most severe fire damage was observed at the bulkhead, dashboard, windshield, and steering column. The burn patterns observed to the interior area progressed upward and outward from the engine compartment. After a review of the progression of the burn patterns, it was determined the fire progressed from the engine compartment into the mail side compartment through the design openings in the bulkhead and subsequent failure of the windshield. A distinct "U" shaped fire pattern was identified at the bulkhead adjacent to the fuel delivery system.

Photograph 10
"U" fire pattern adjacent to fuel system.

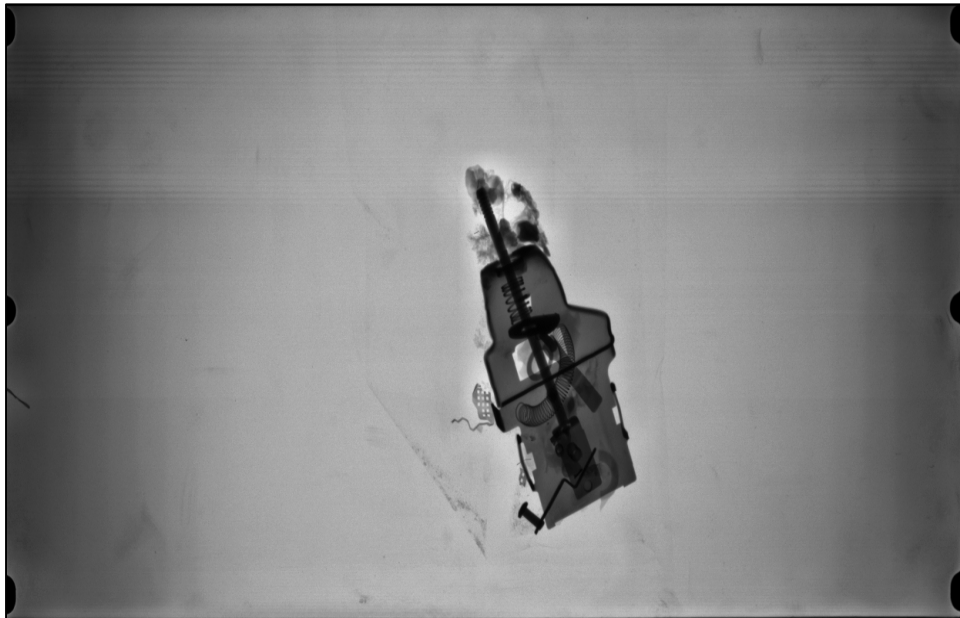
Photograph 12
X-ray image of head lamp switch.

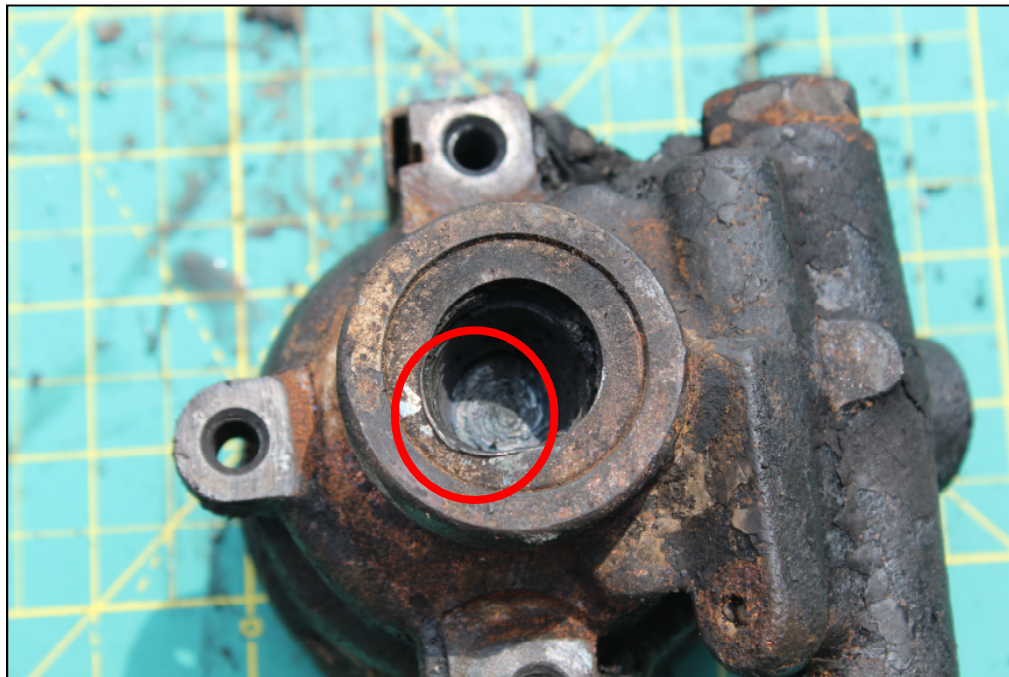
Photograph 10

View of the shaft entry point of the power steering pump. Note deformation.

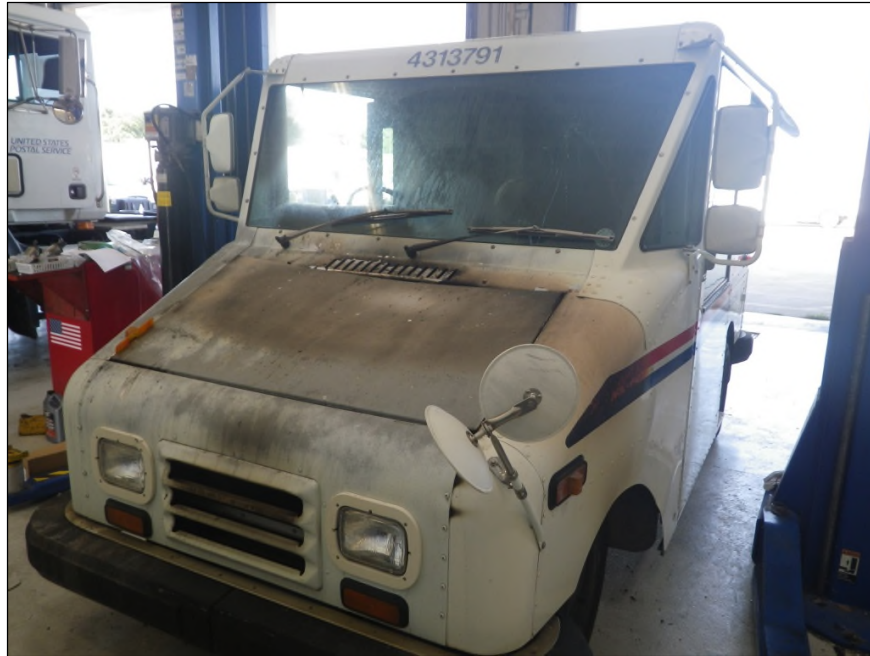
Photograph 1

Front view of LLV, with fire-damaged engine hood and windshield.

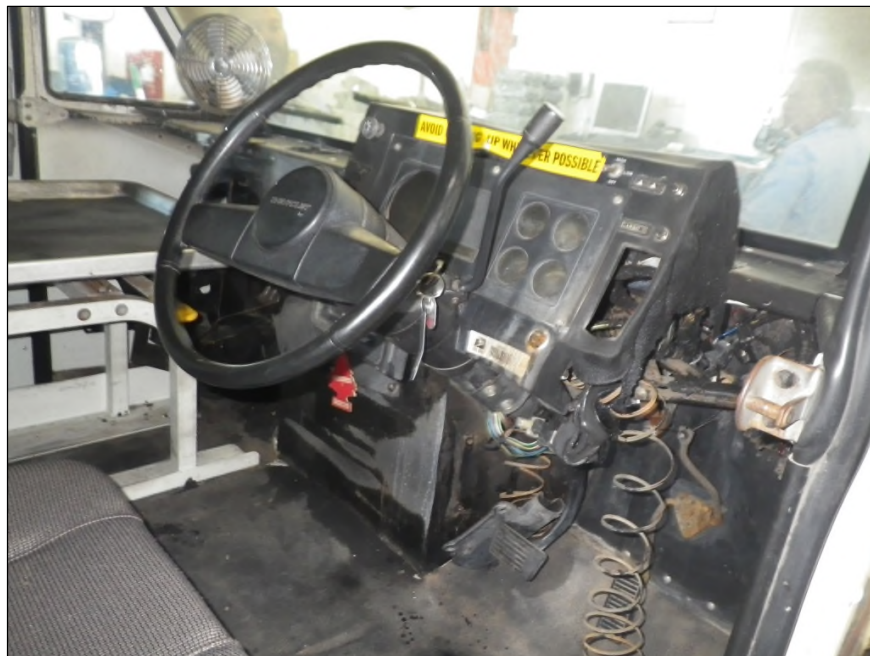
Photograph 2

View of fire damage to underneath dashboard area.

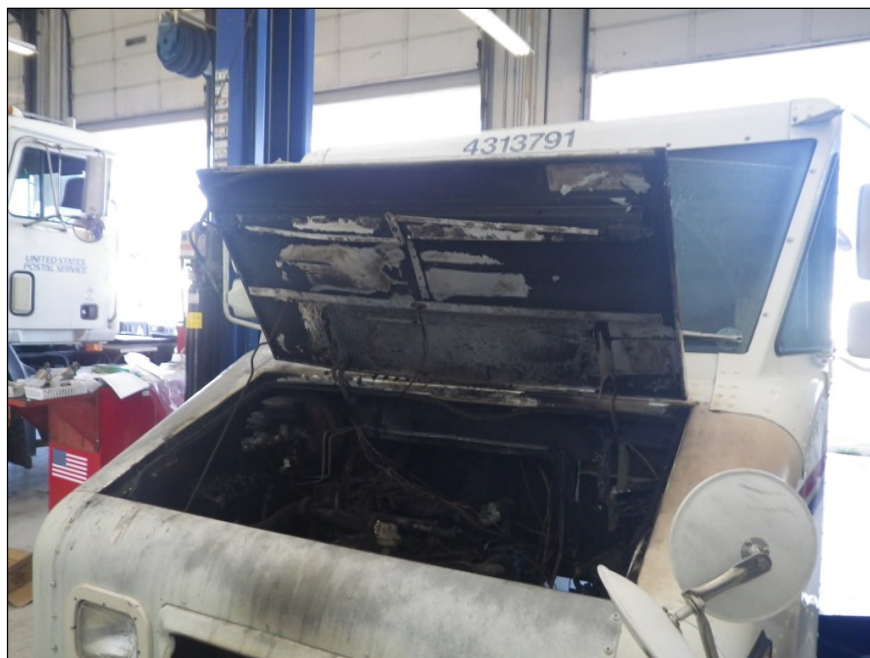
Photograph 4

View of fire-damaged engine compartment.

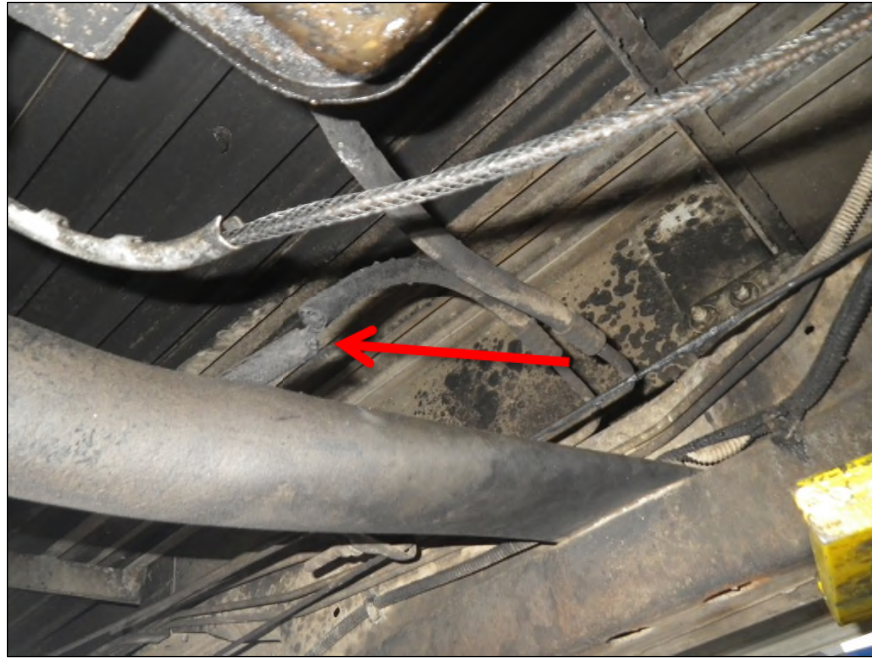
Photograph 5

View of rubber fuel line, which appeared to have been cracked or split prior to the fire.

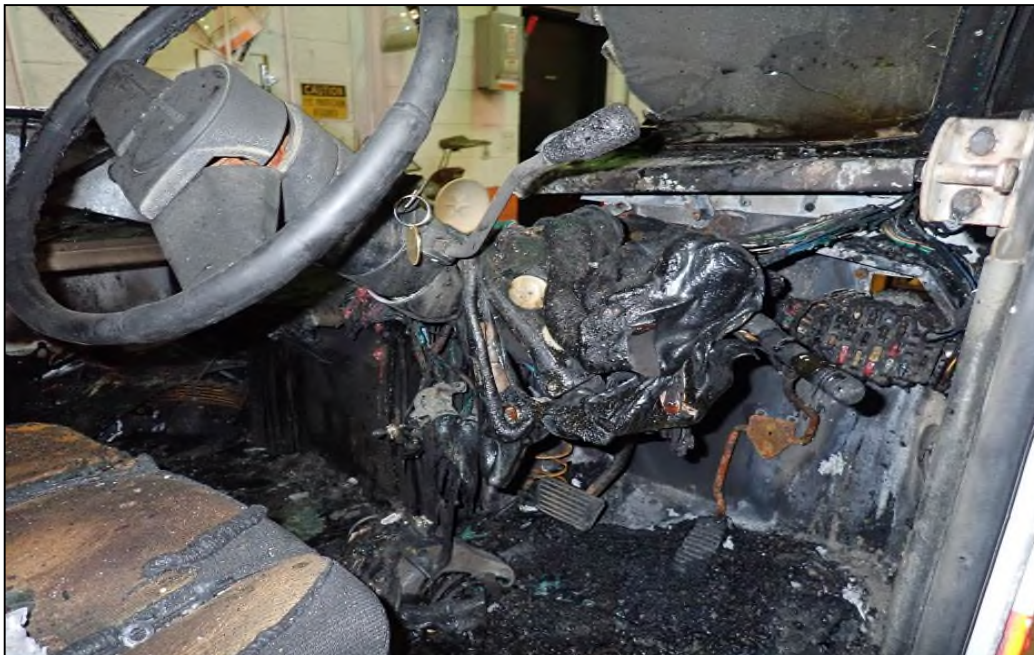
Photograph 6
Passenger compartment of vehicle.

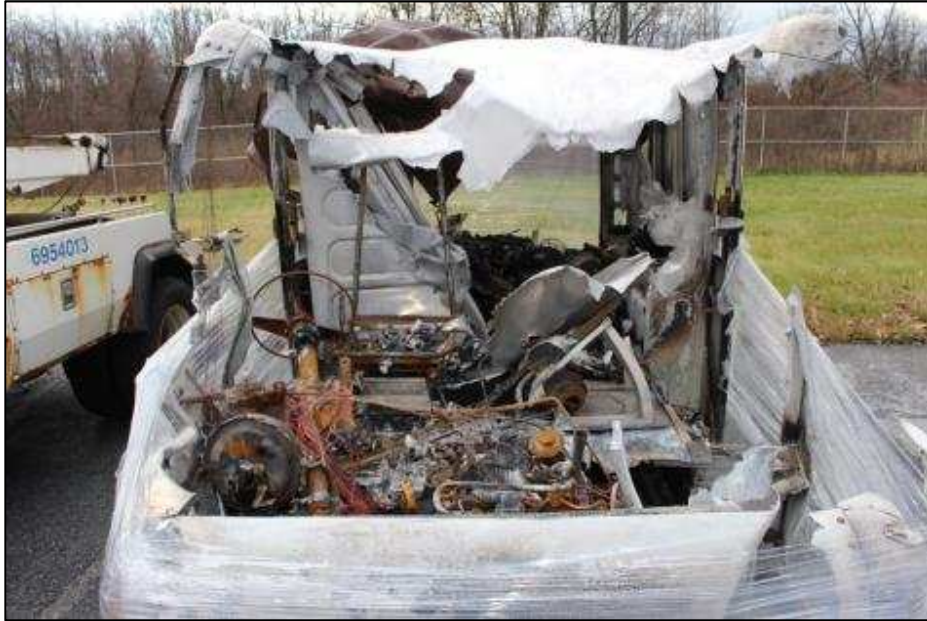
The engine compartment was examined. Flame impingement damage was observed throughout the engine compartment with the most severe damage in the compartment located along the rear of the engine closest to the firewall. The plastic and rubber engine components were consumed. The air filter components were also consumed.

Photograph 5
Engine compartment

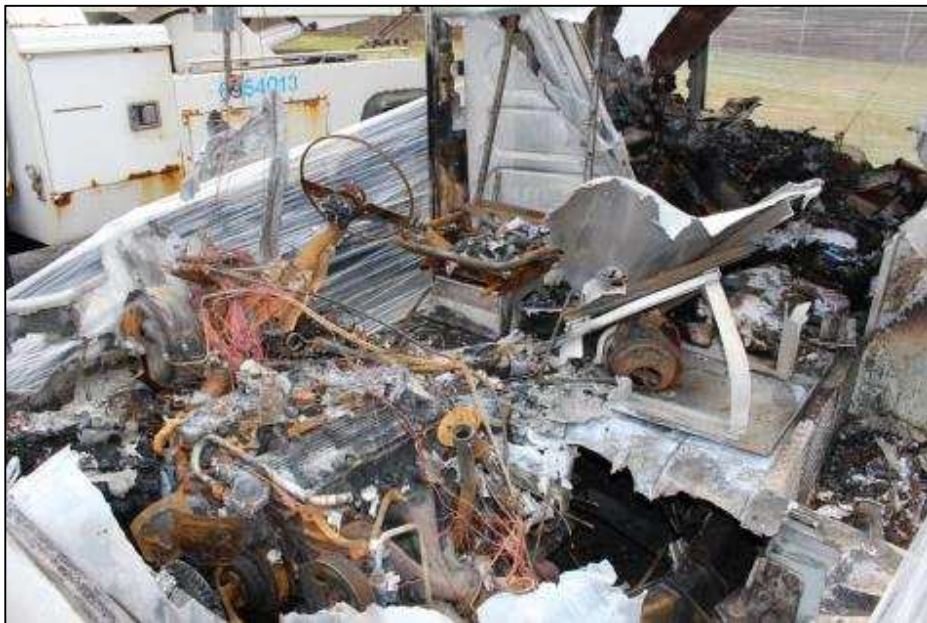
Photograph 6
Engine compartment

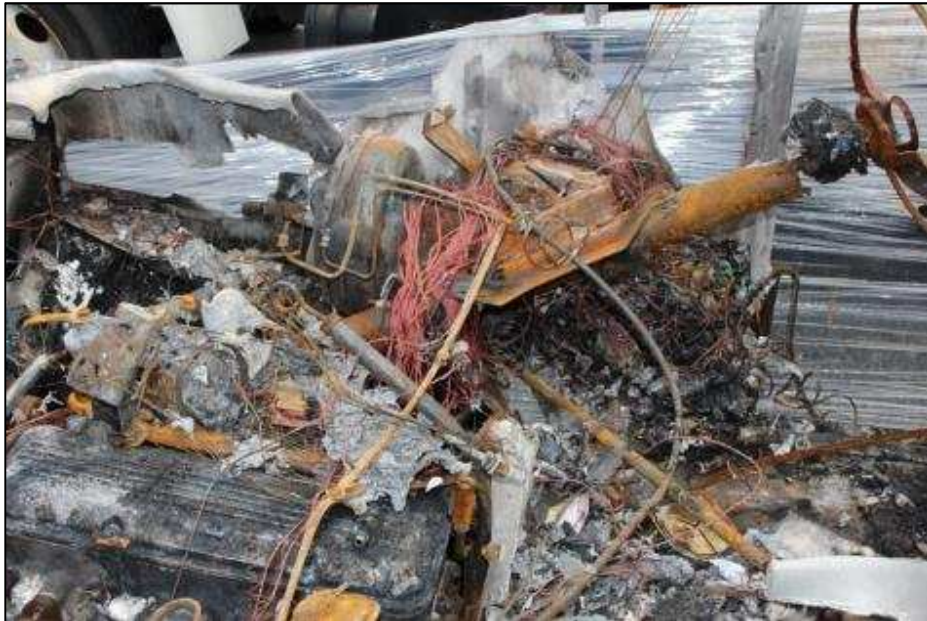
Examination of the interior of the vehicle revealed the most severe fire damage had occurred to the dashboard area. The dashboard had melted and the majority of the electrical wiring and other components that were housed within the dashboard were severely damaged. The electrical wiring that could be examined did not display any physical evidence of adverse electrical activity. Further examination of the components and electrical wiring that would have been located within the dashboard area could not be examined due to the severity of the fire damage in the area and the lack of remaining physical evidence.

Photograph 7
Dashboard area.

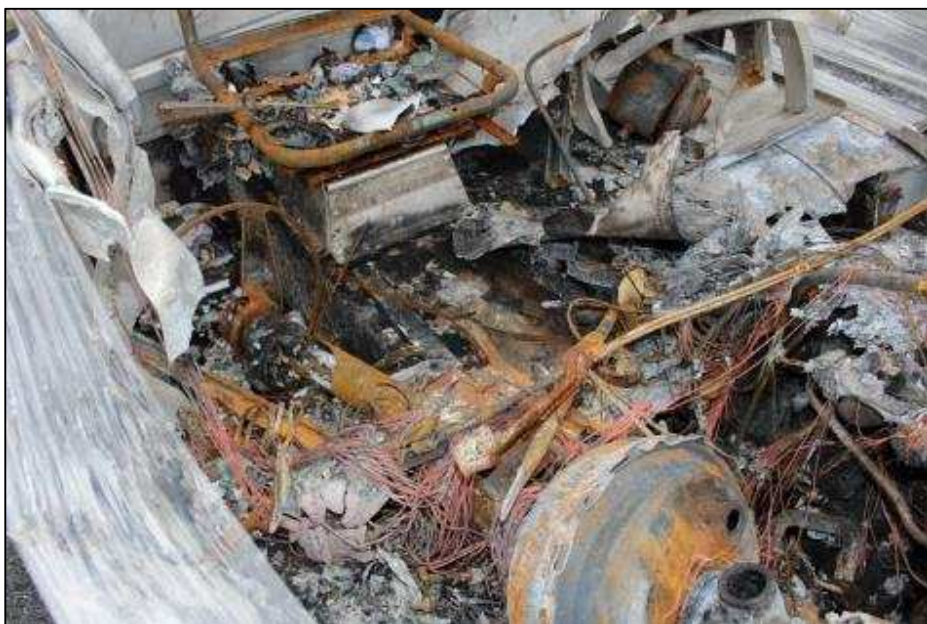
Photograph 8
Dashboard area near driver side.

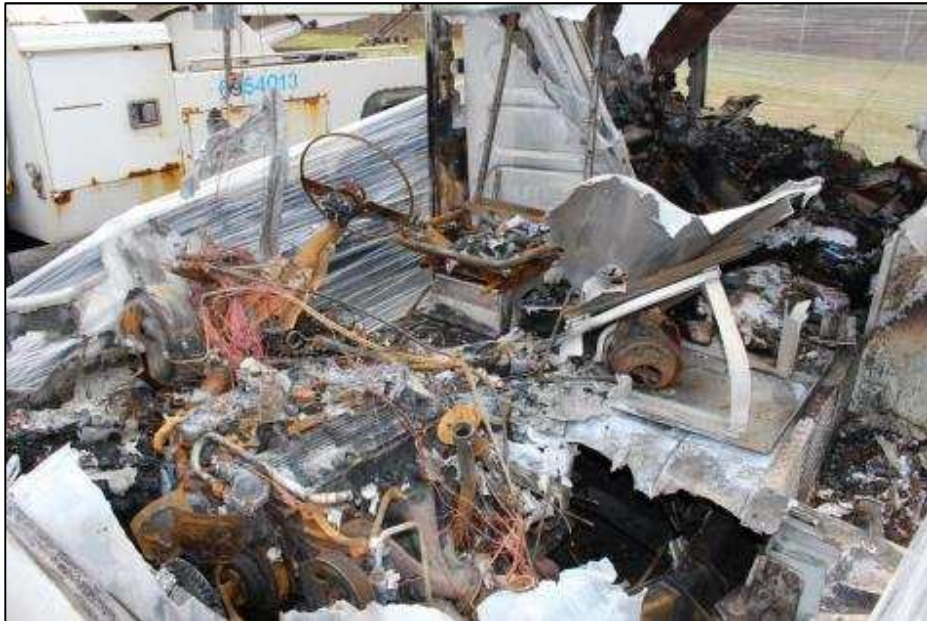
Photograph 9

The fuel system was examined and revealed it to be the original GM fuel filter system which was severely damaged. The fuel lines were routed along the rear of the engine. The fuel filter was located just to the rear of the engine on the left side. The filter was intact but all fuel lines to the engine were consumed. The battery for the vehicle is located at the front right side of the engine compartment and had sustained severe fire damage and was nearly consumed.

Area above fuel filter. Bottom right of photo.

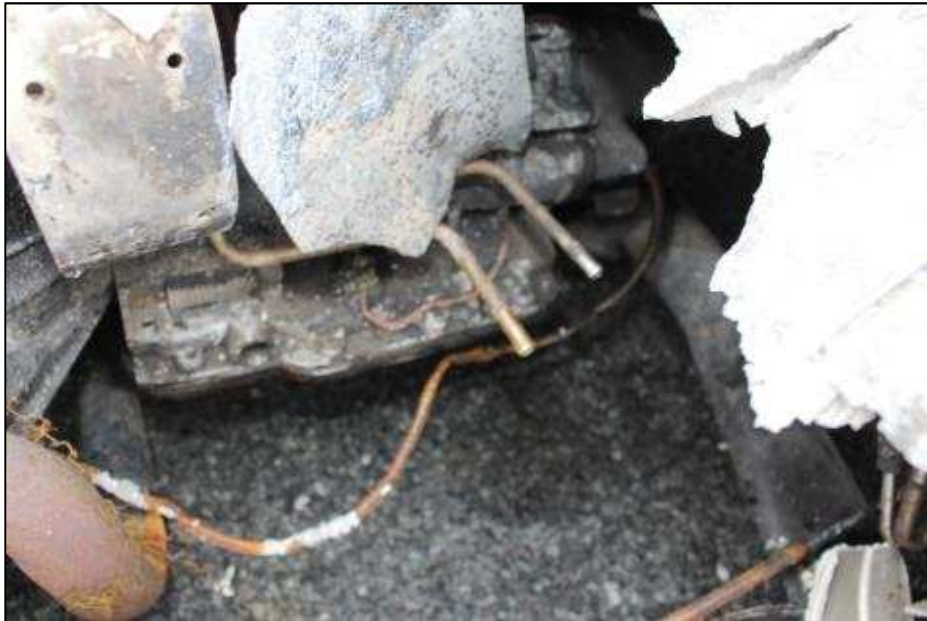
Photograph 11
Fuel lines.

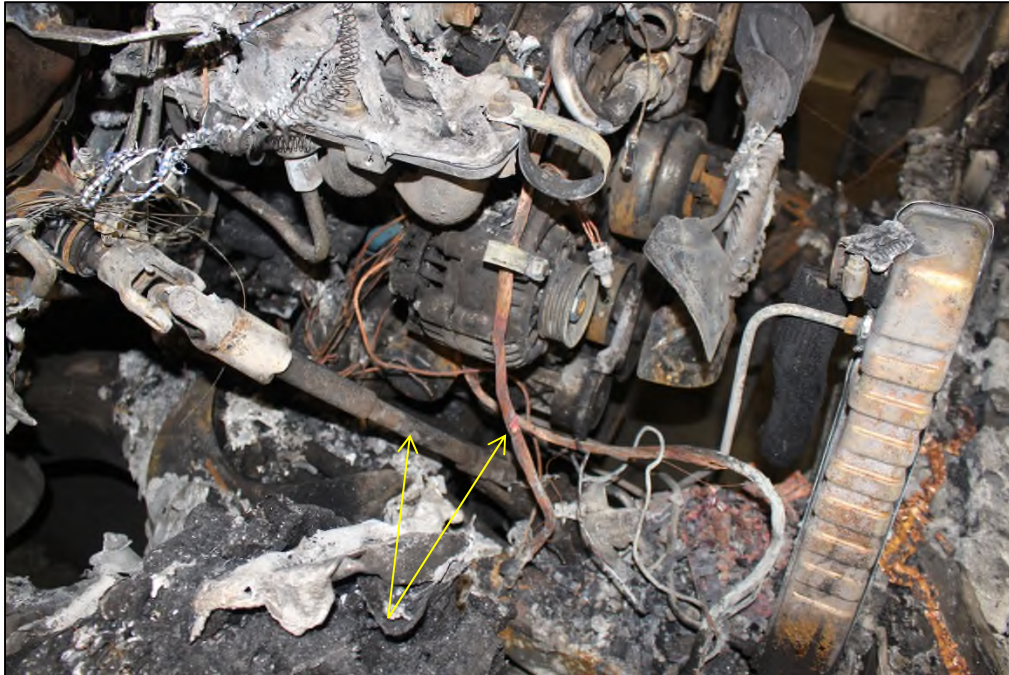
Photograph 3

Right side of engine. Battery hot lead arc and intermediate shaft (yellow arrows).

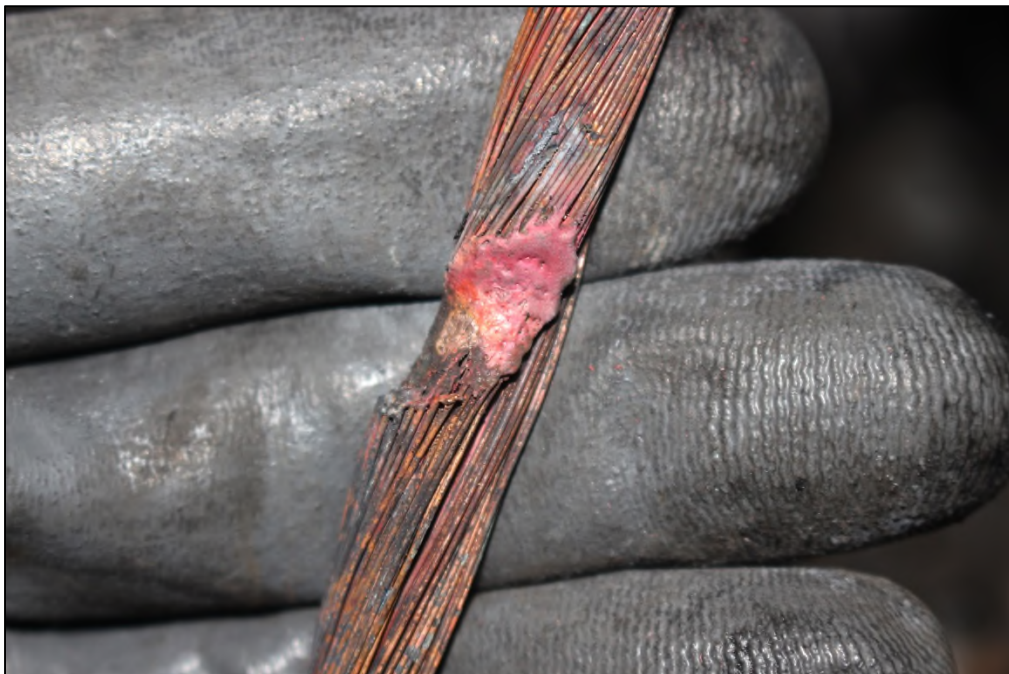
Photograph 4

Closer view of battery cable arc.

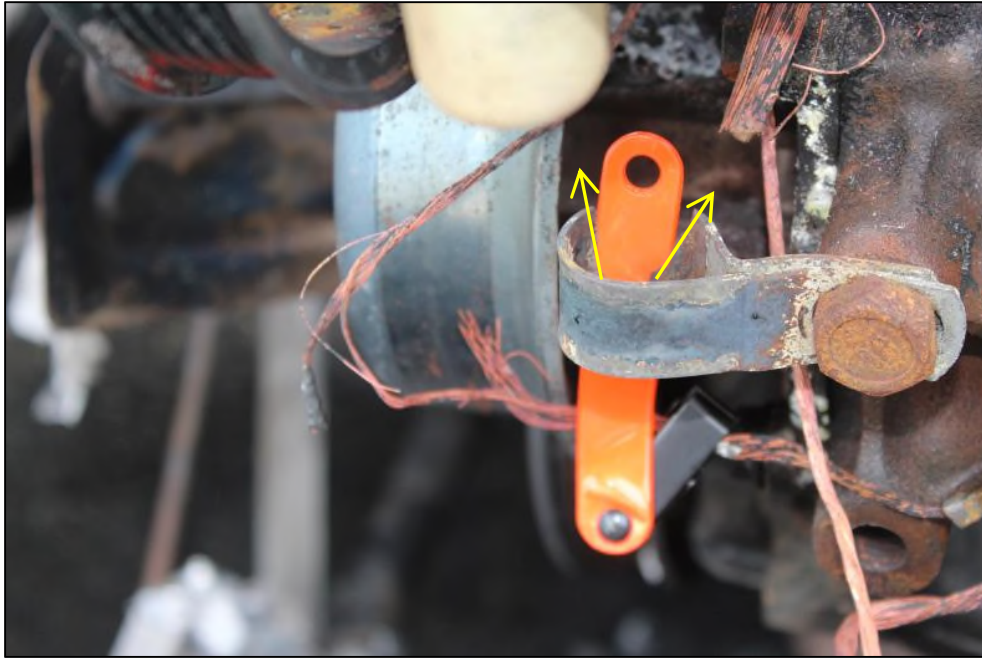
Photograph 11

Damaged aluminum cable clamp that routed the positive battery cable to the starter.

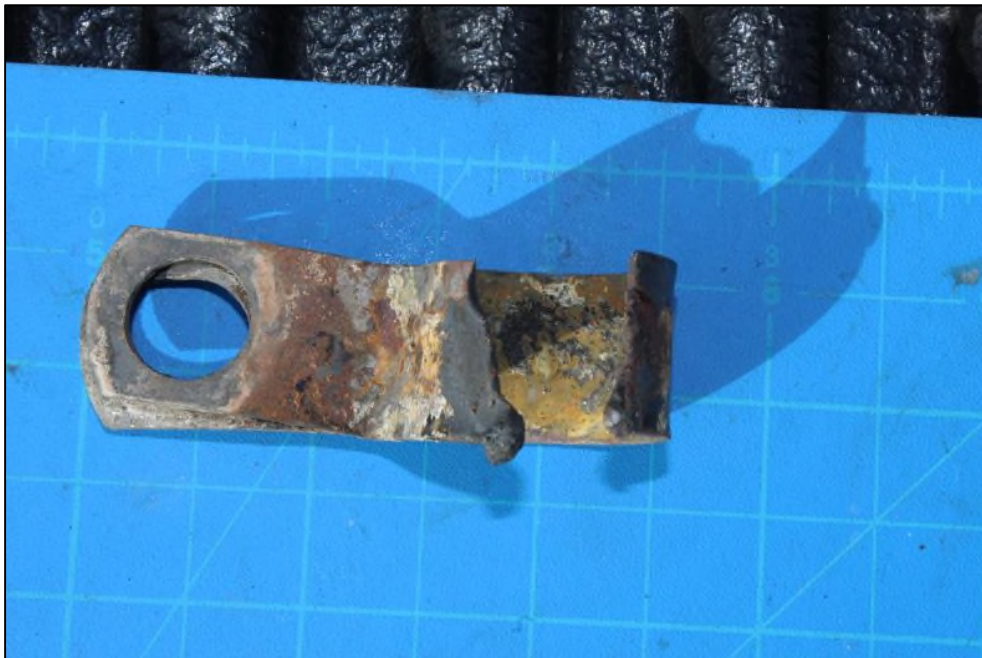
Photograph 12

Damaged aluminum cable clamp.

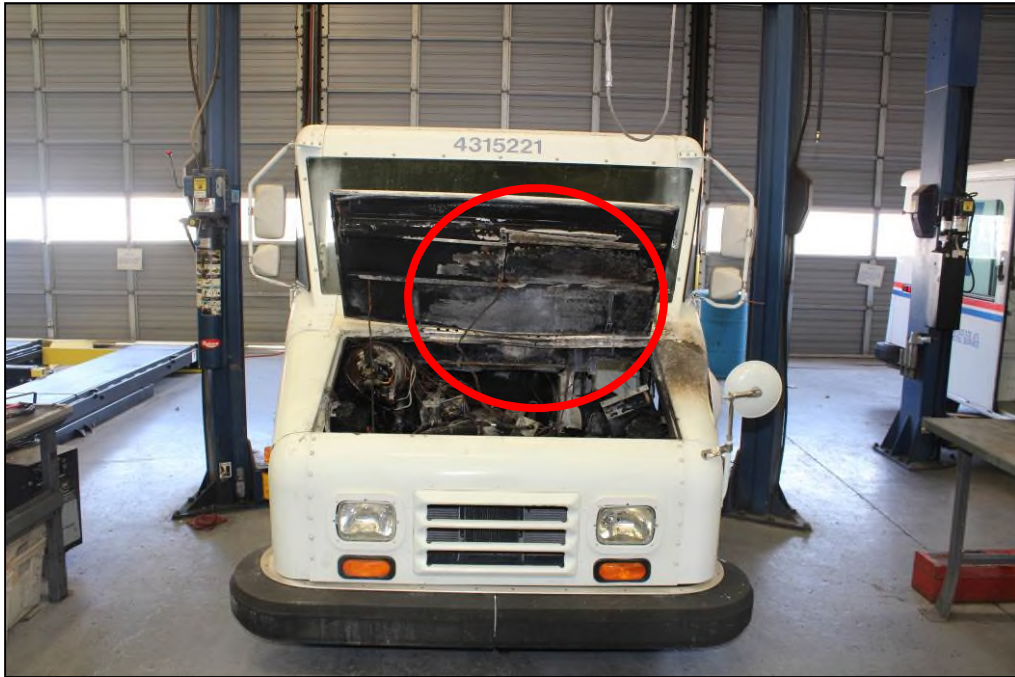
Photograph 1

Underside of vehicle hood, note fire pattern.

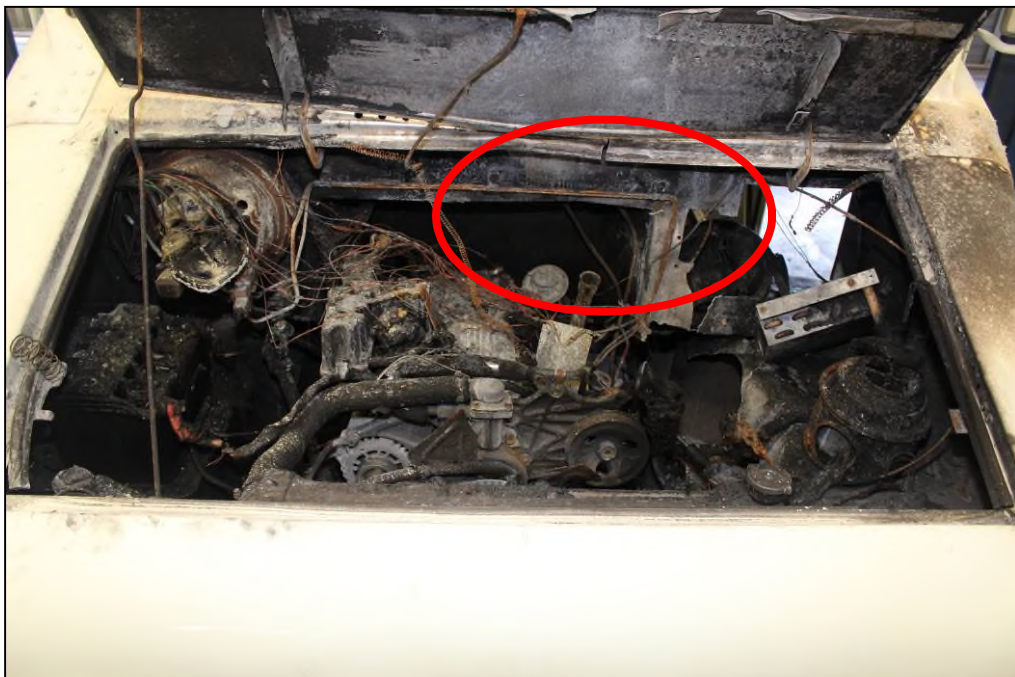
Photograph 2

Engine compartment, area of fire origin.

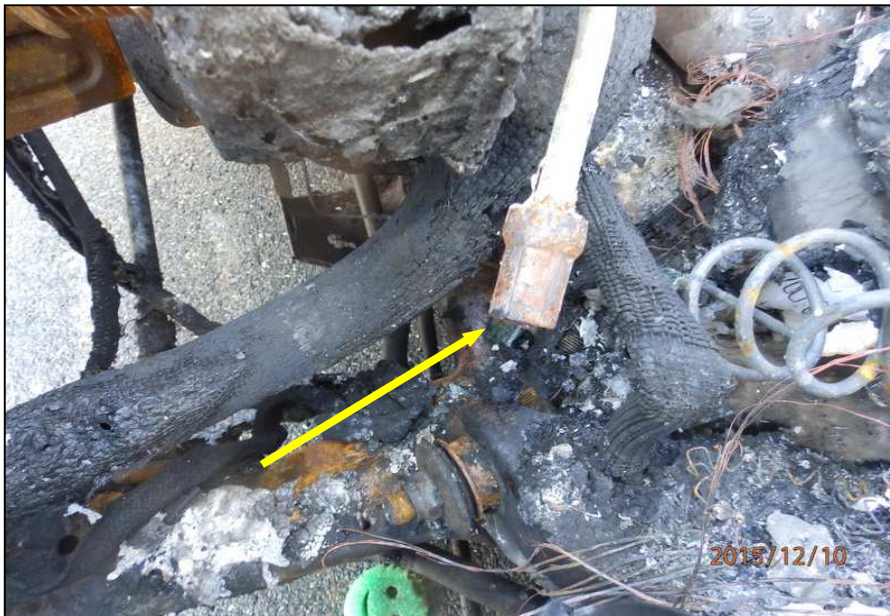
Photograph 2

A view of the power steering high pressure fixed line at the transition point to flexible hose.

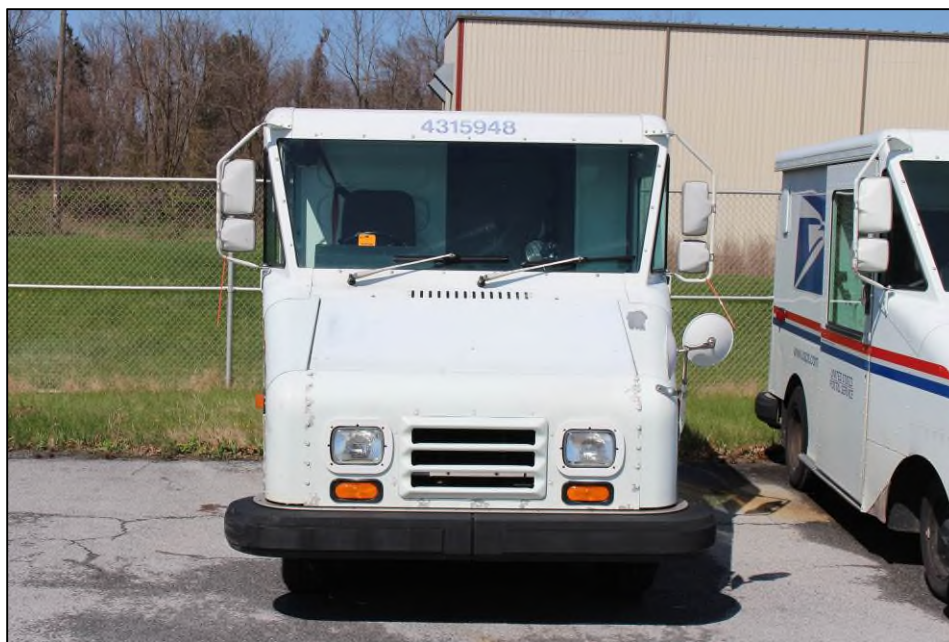
Photograph 1
Front of vehicle.

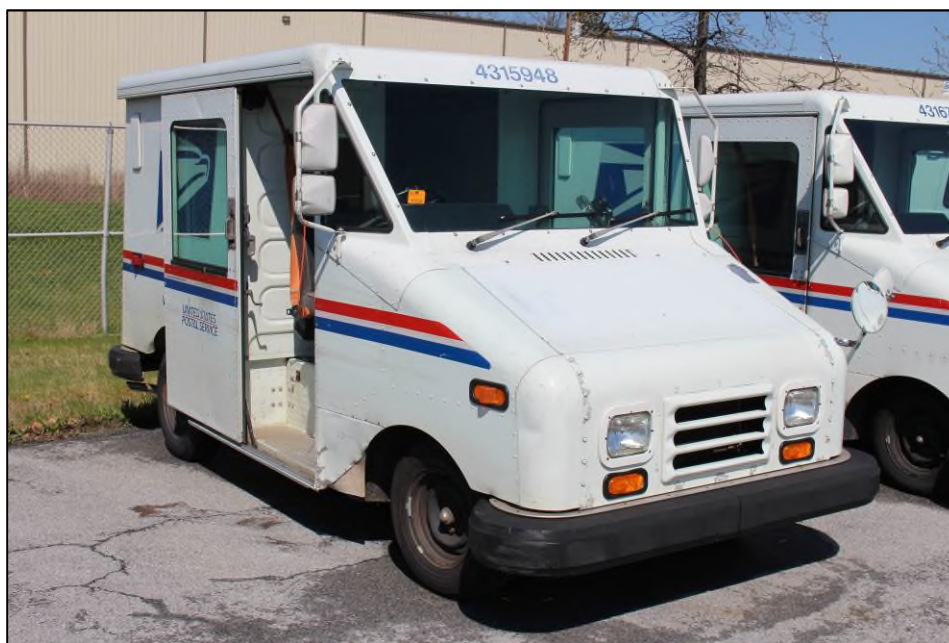
Photograph 2
Drivers side of vehicle.

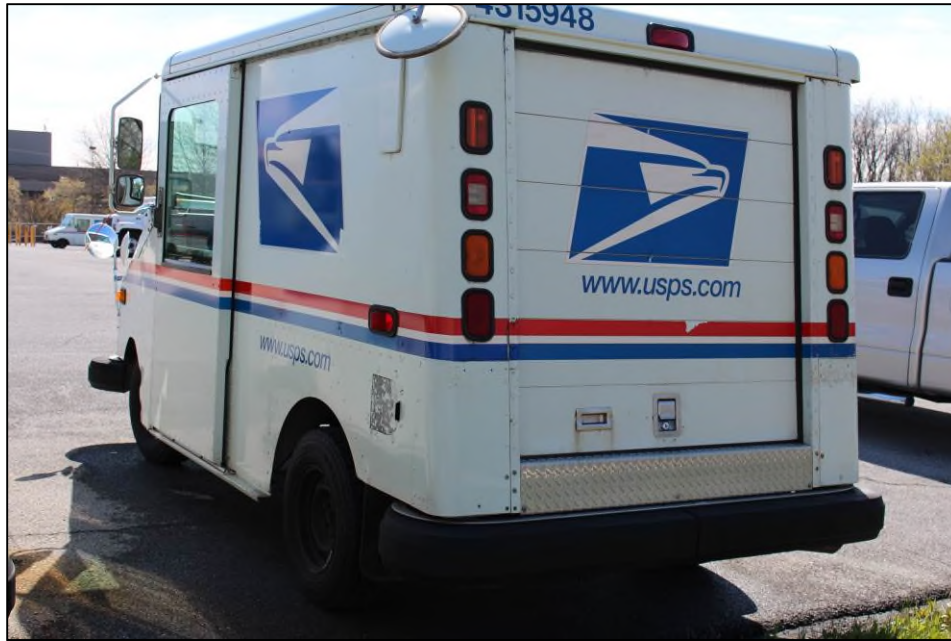
Photograph 3
Rear of vehicle.

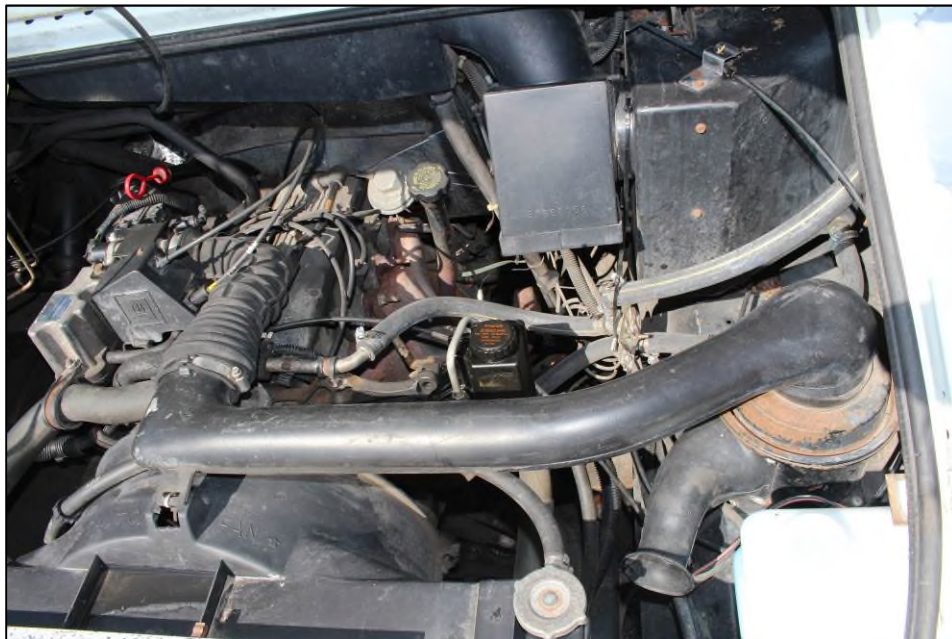
Photograph 4
Passenger side of engine compartment.

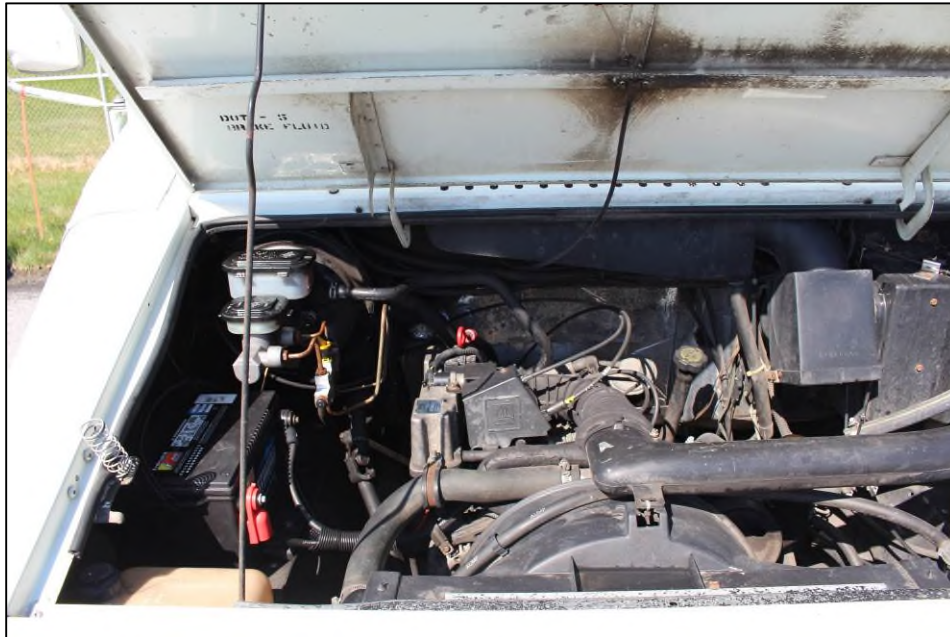
Photograph 5
Drivers side of engine compartment.

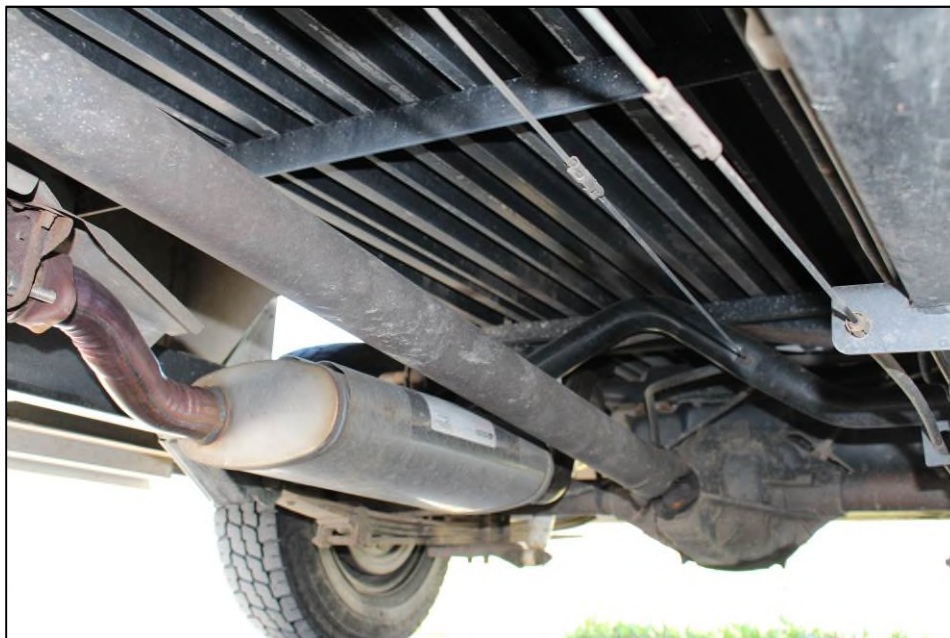
Photograph 6
Undercarriage of vehicle from passenger side.

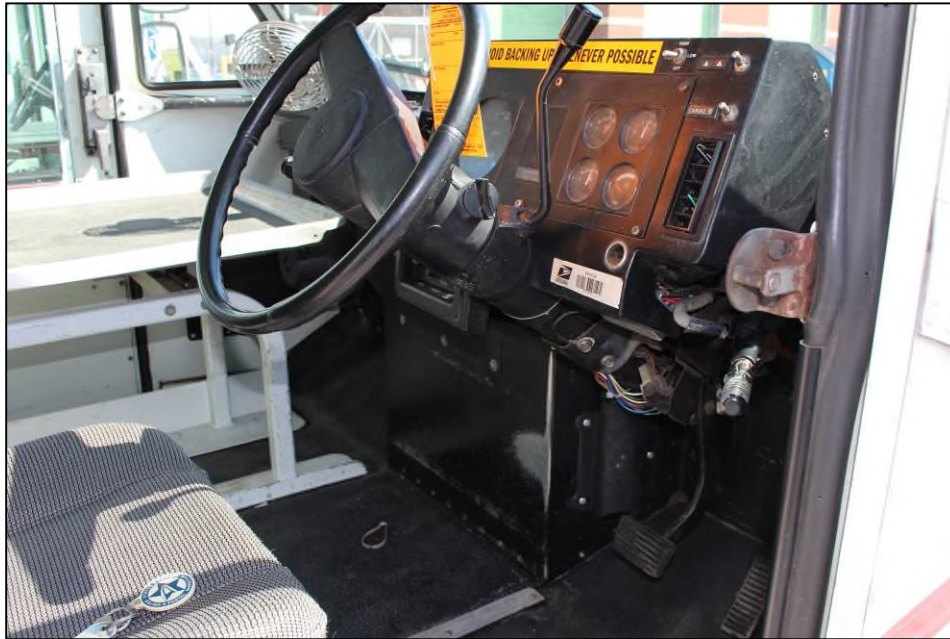
Photograph 7
Interior of vehicle.
